Water/Power Chain of Events, Nov. 17, 2018

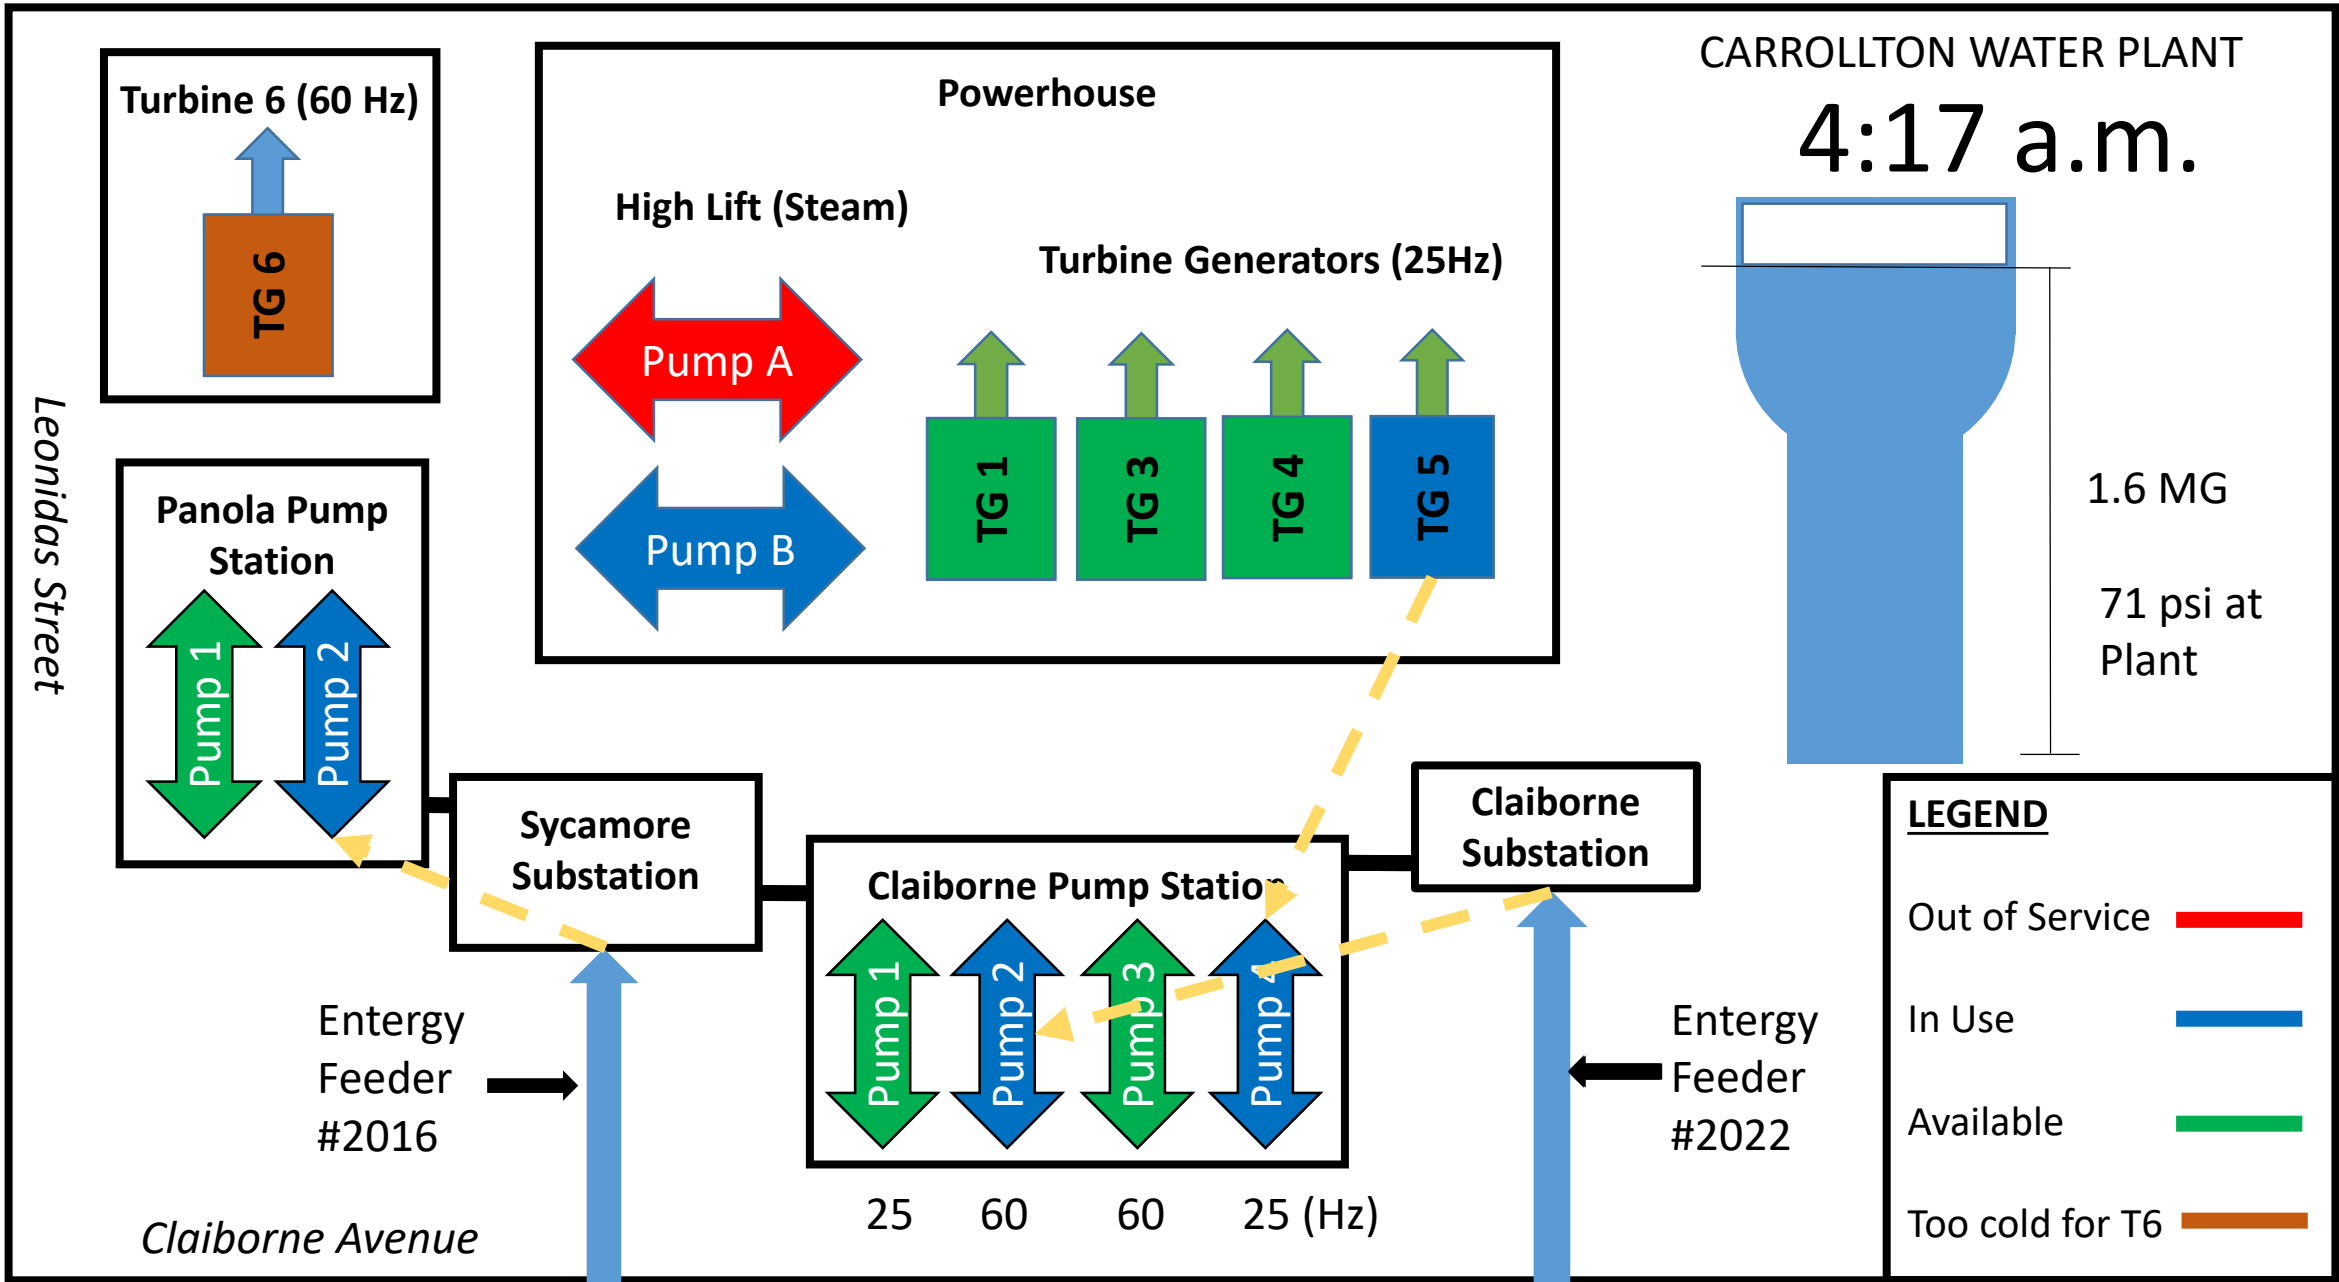
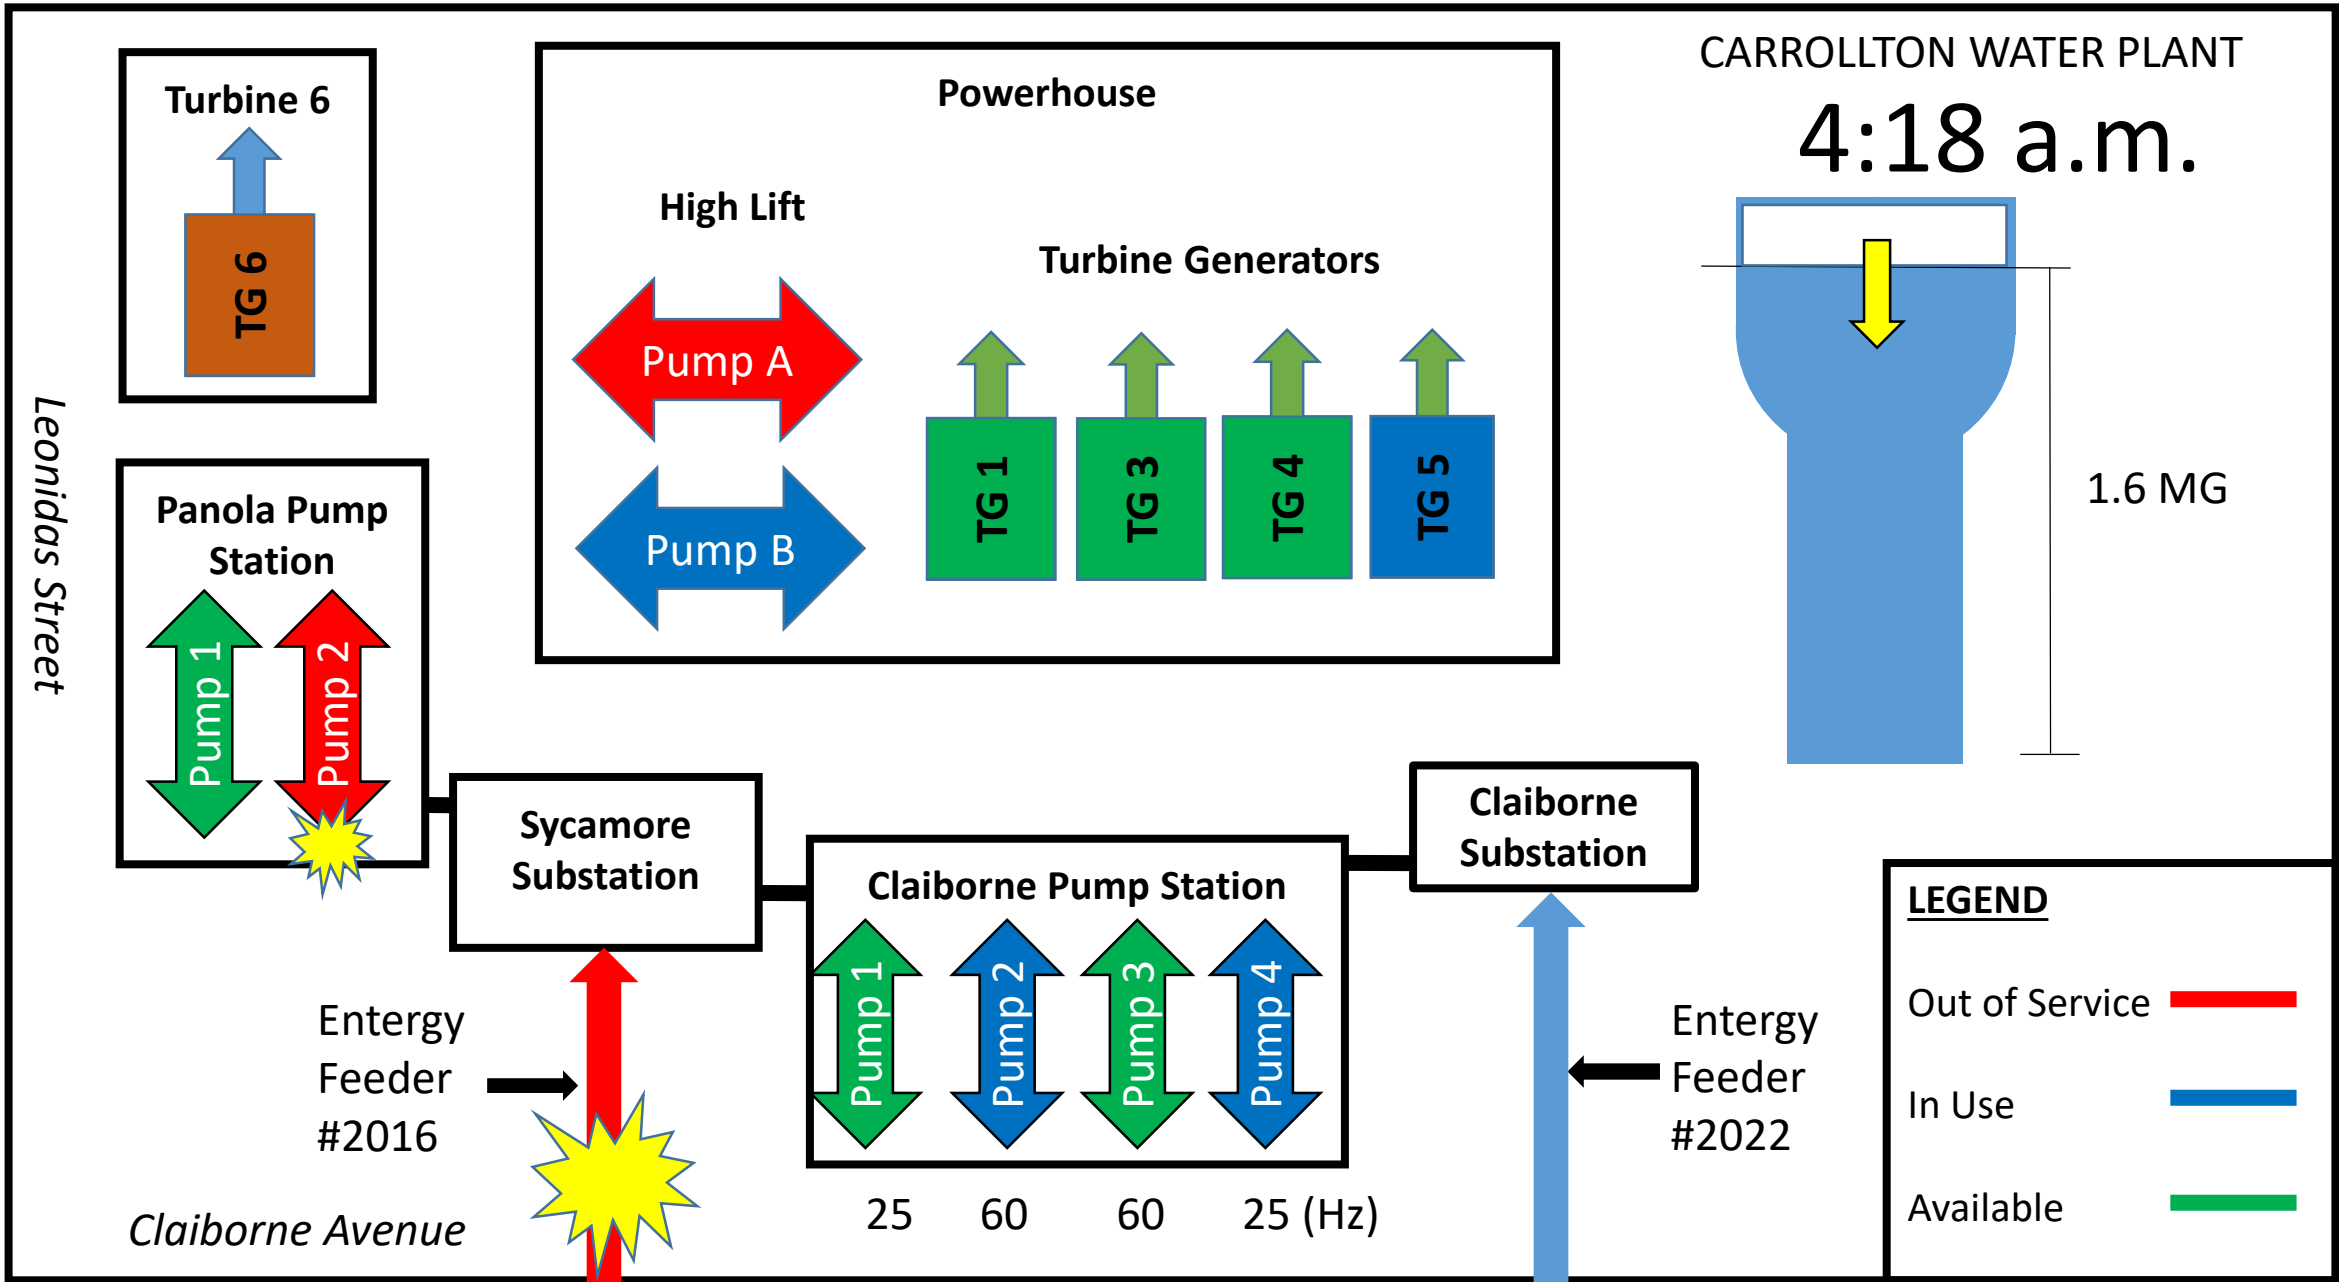
CARROLLTON WATER PLANT
4:18 a.m.

1.6 MG

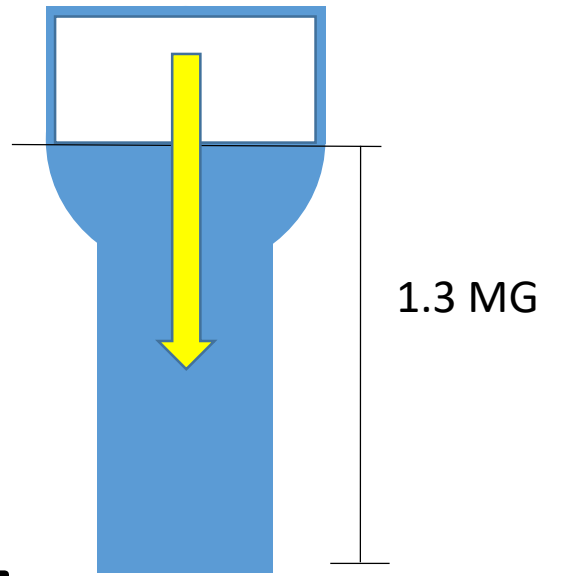
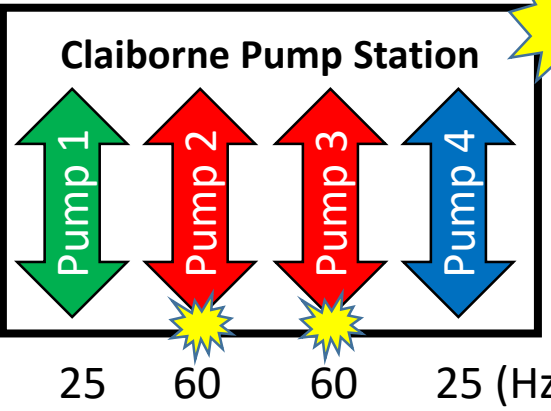
CARROLLTON WATER PLANT
6:19 a.m.

Main Breaker Trips

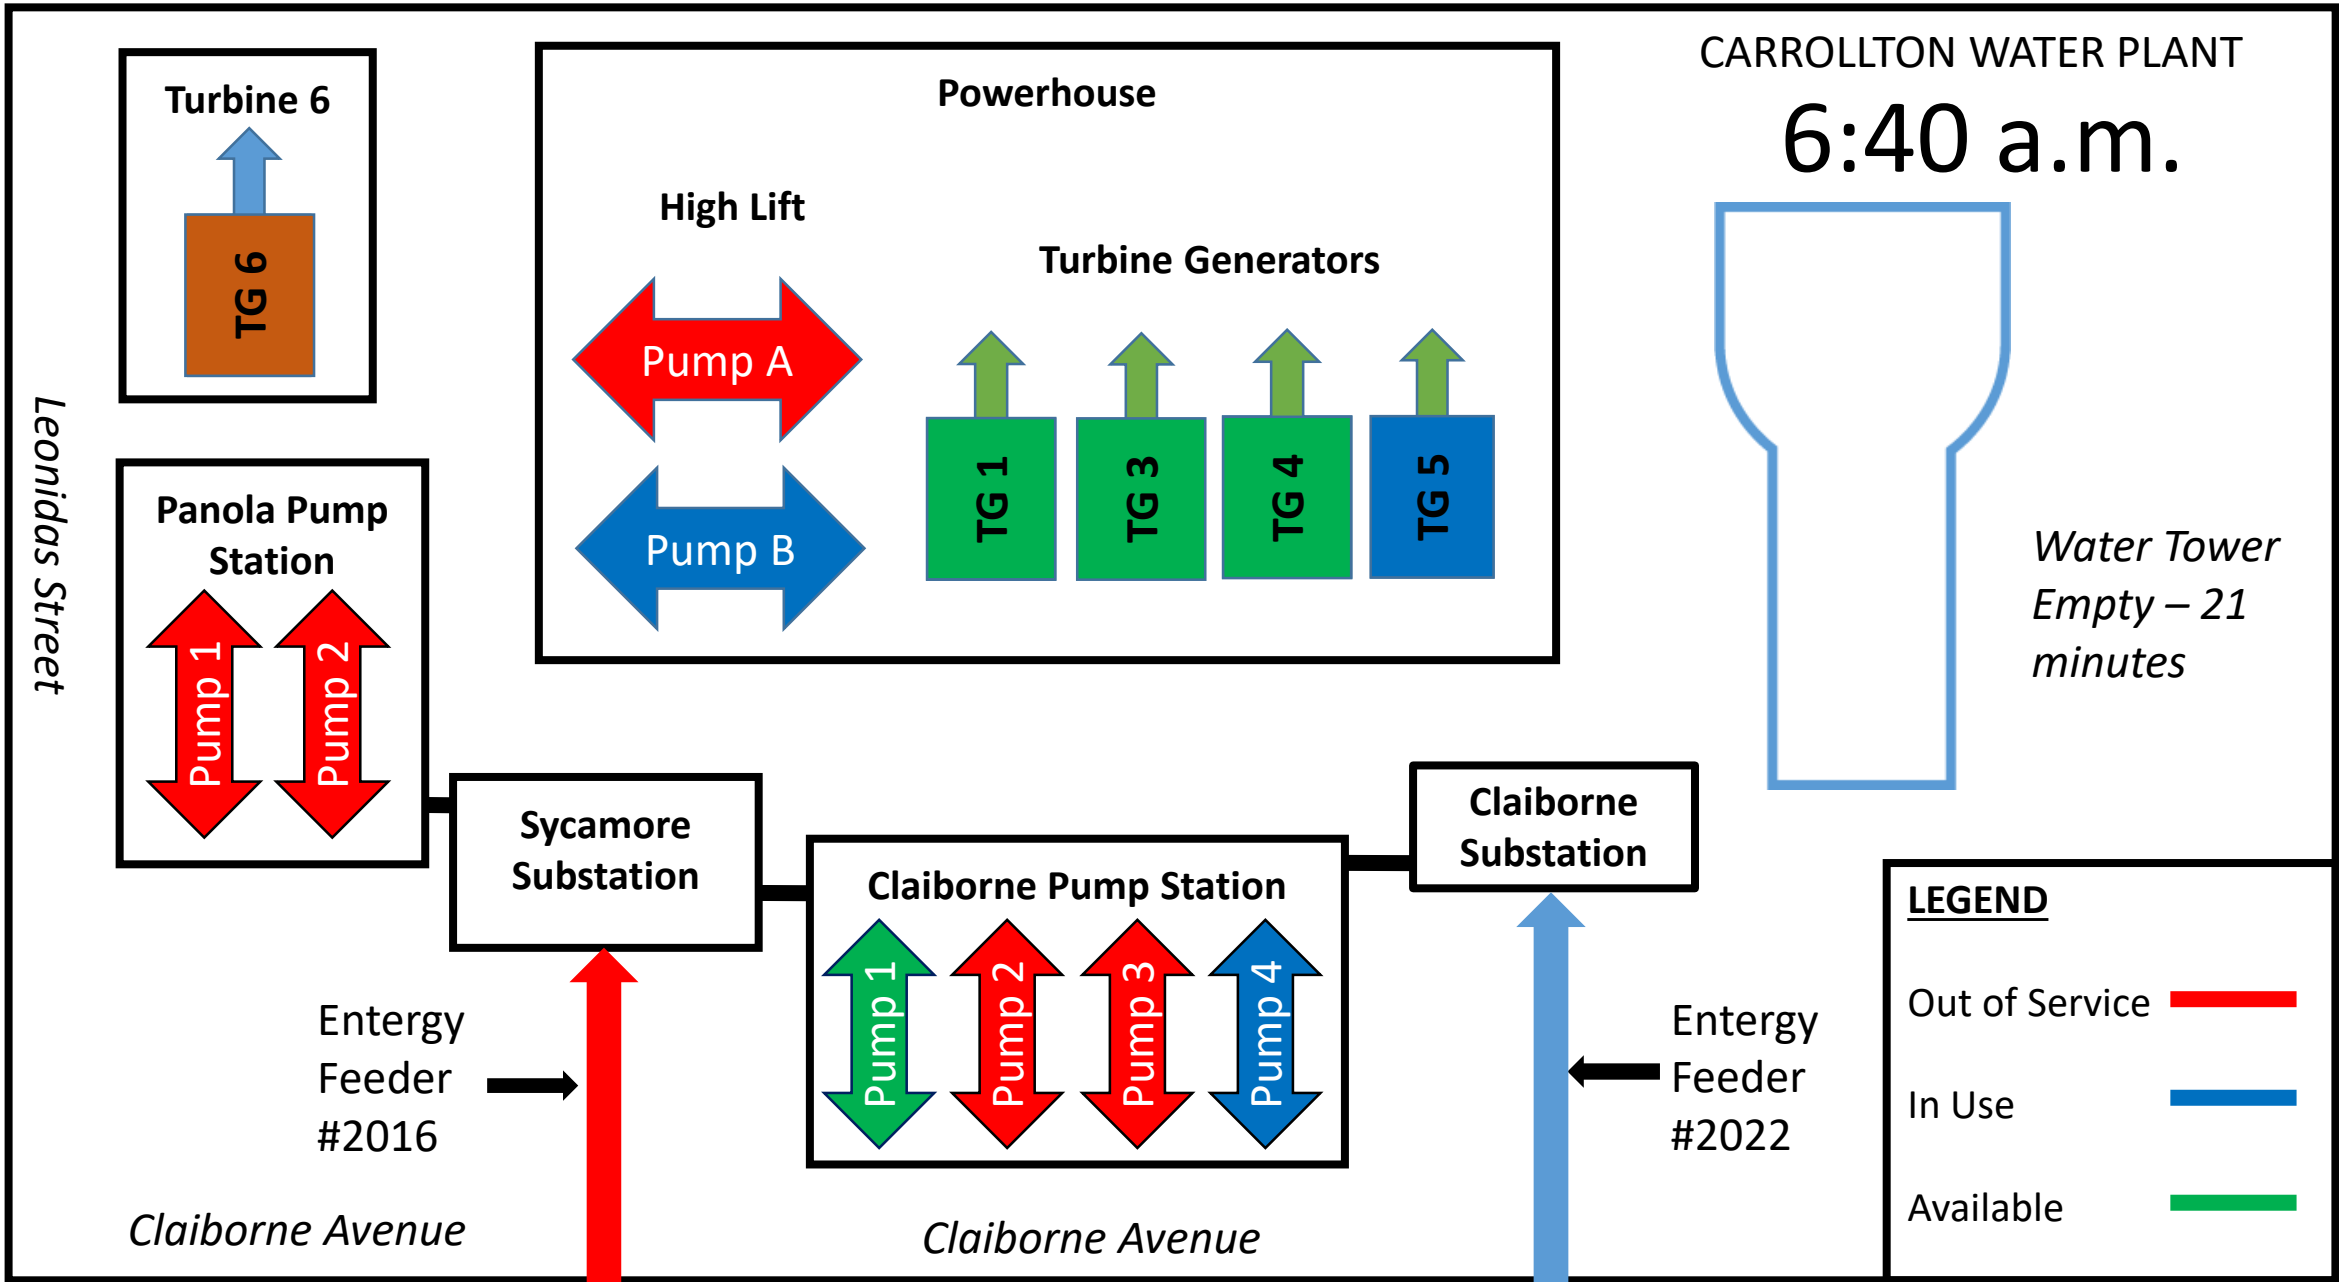
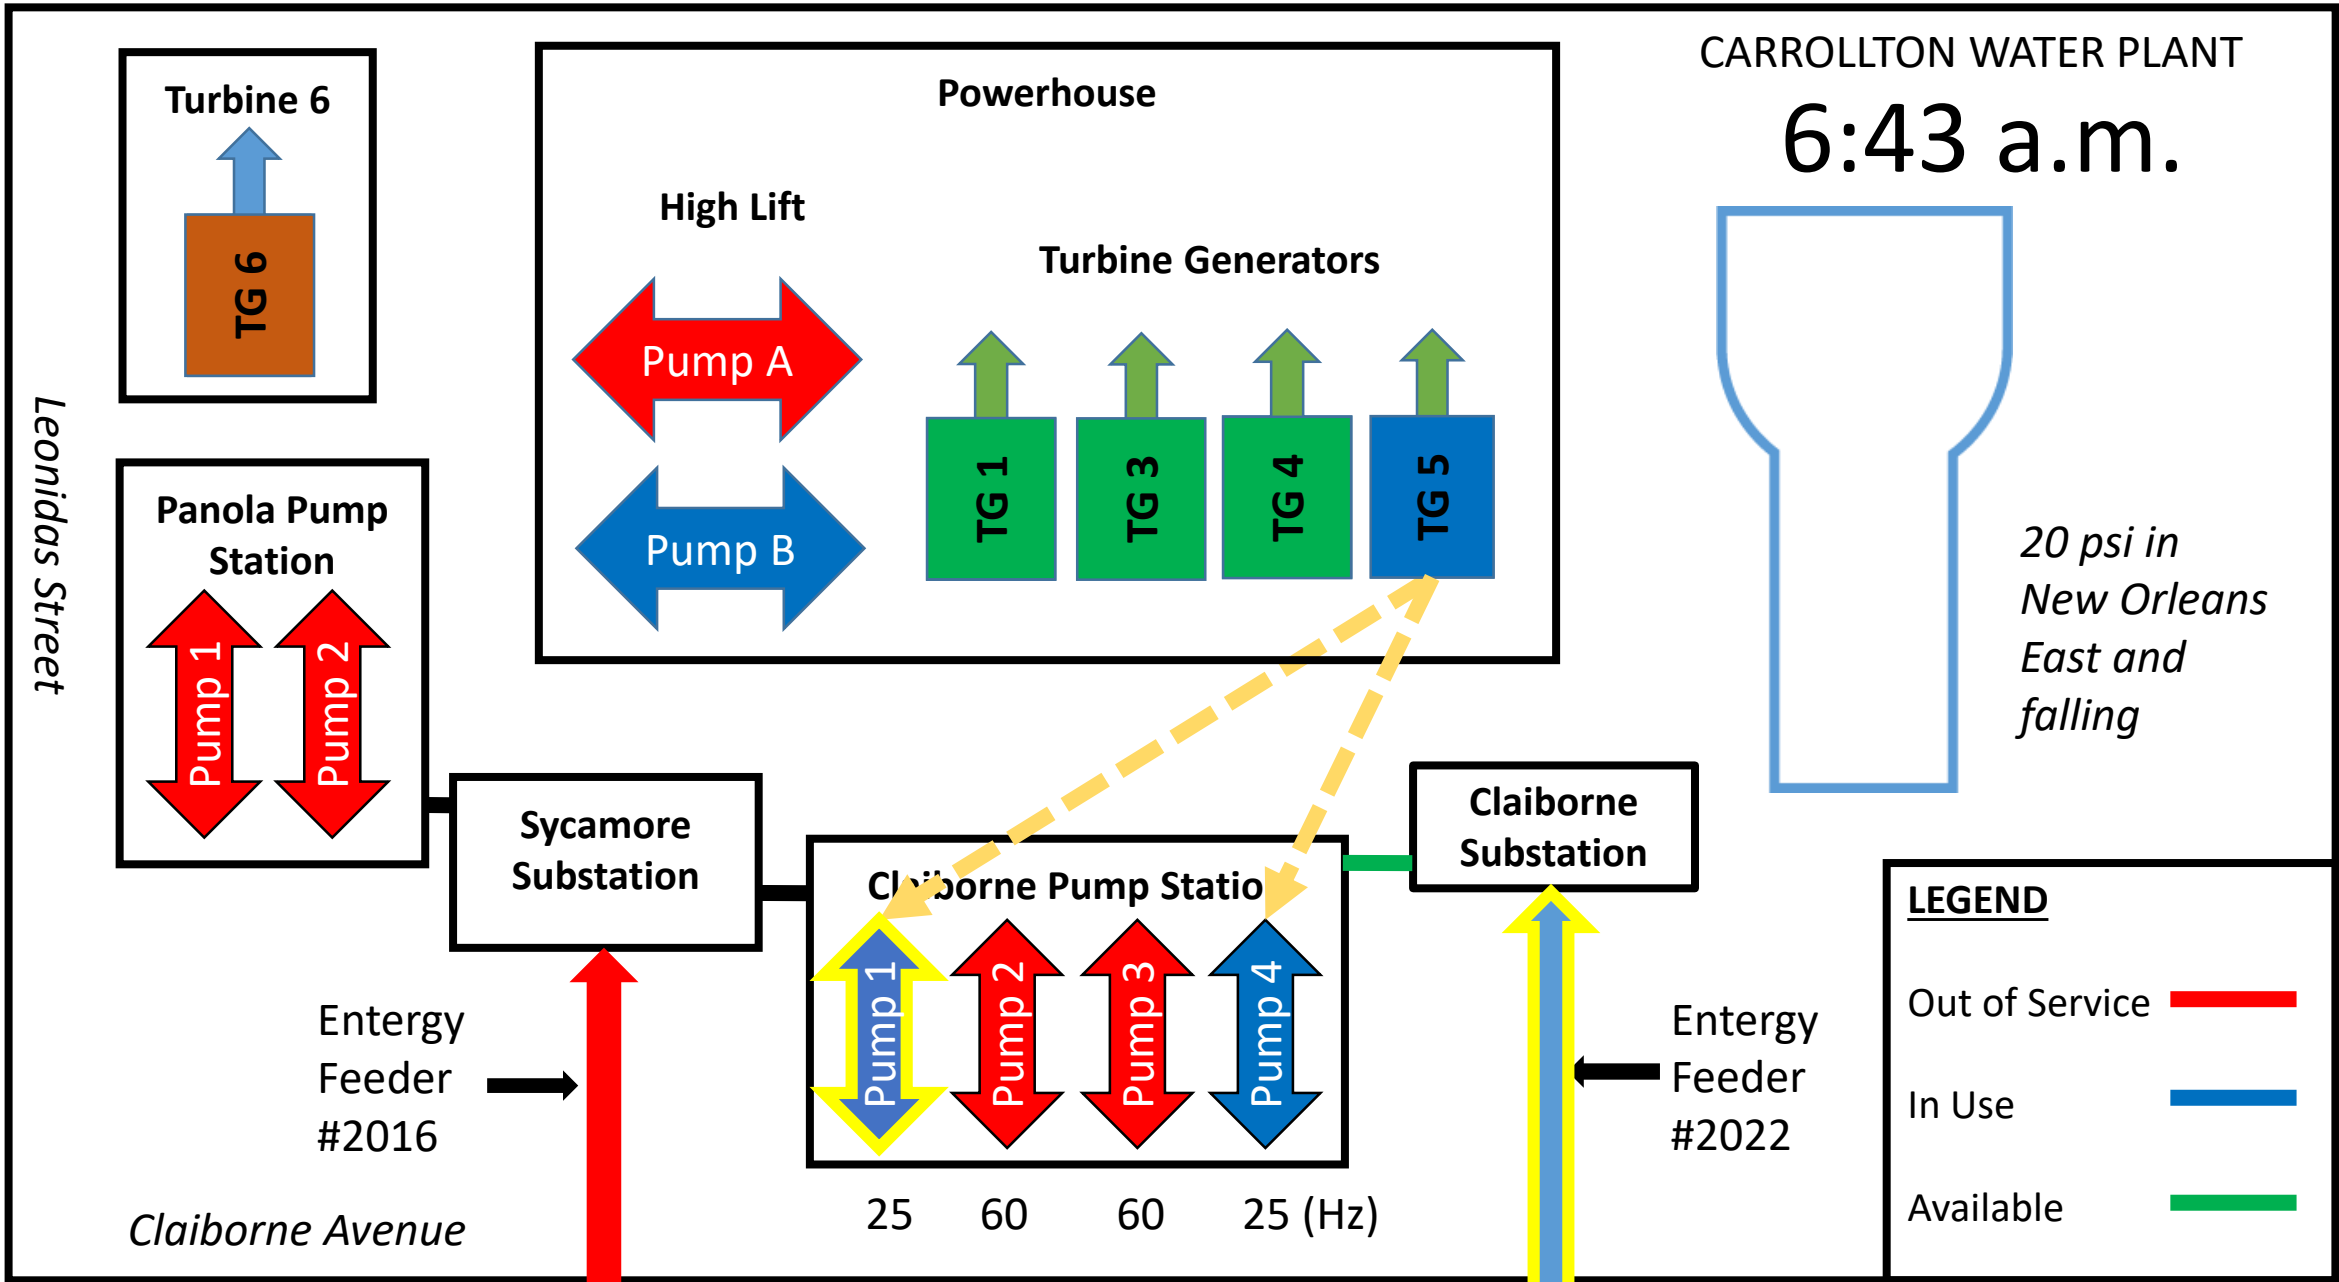
CARROLLTON WATER PLANT
6:43 a.m.

20 psi in New Orleans East and falling

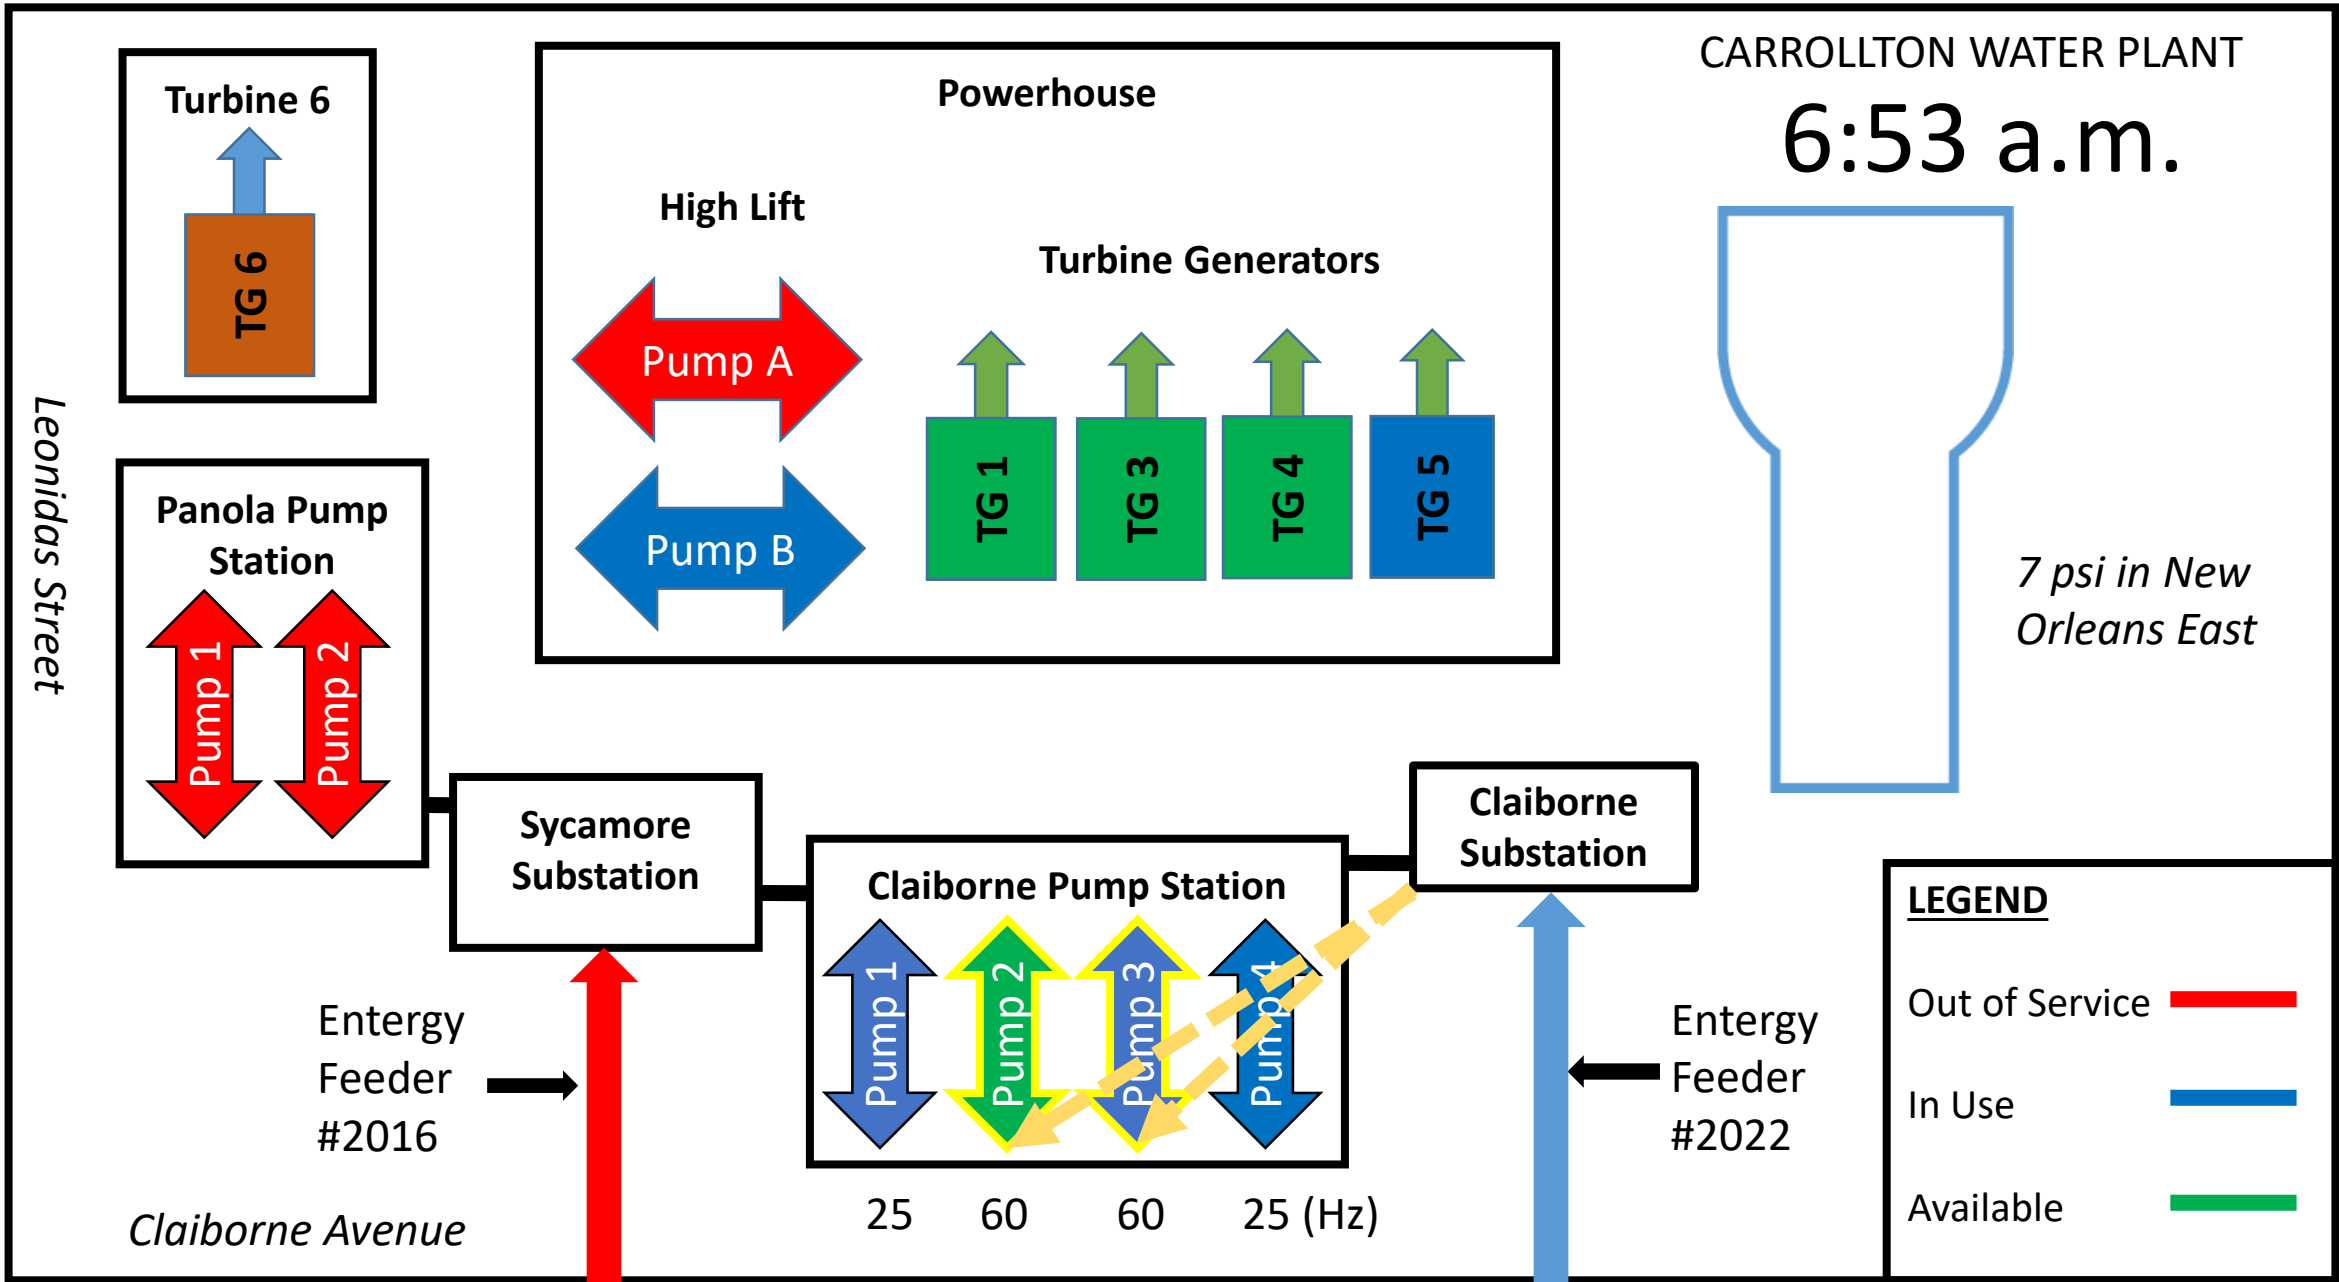
7 psi in New Orleans East

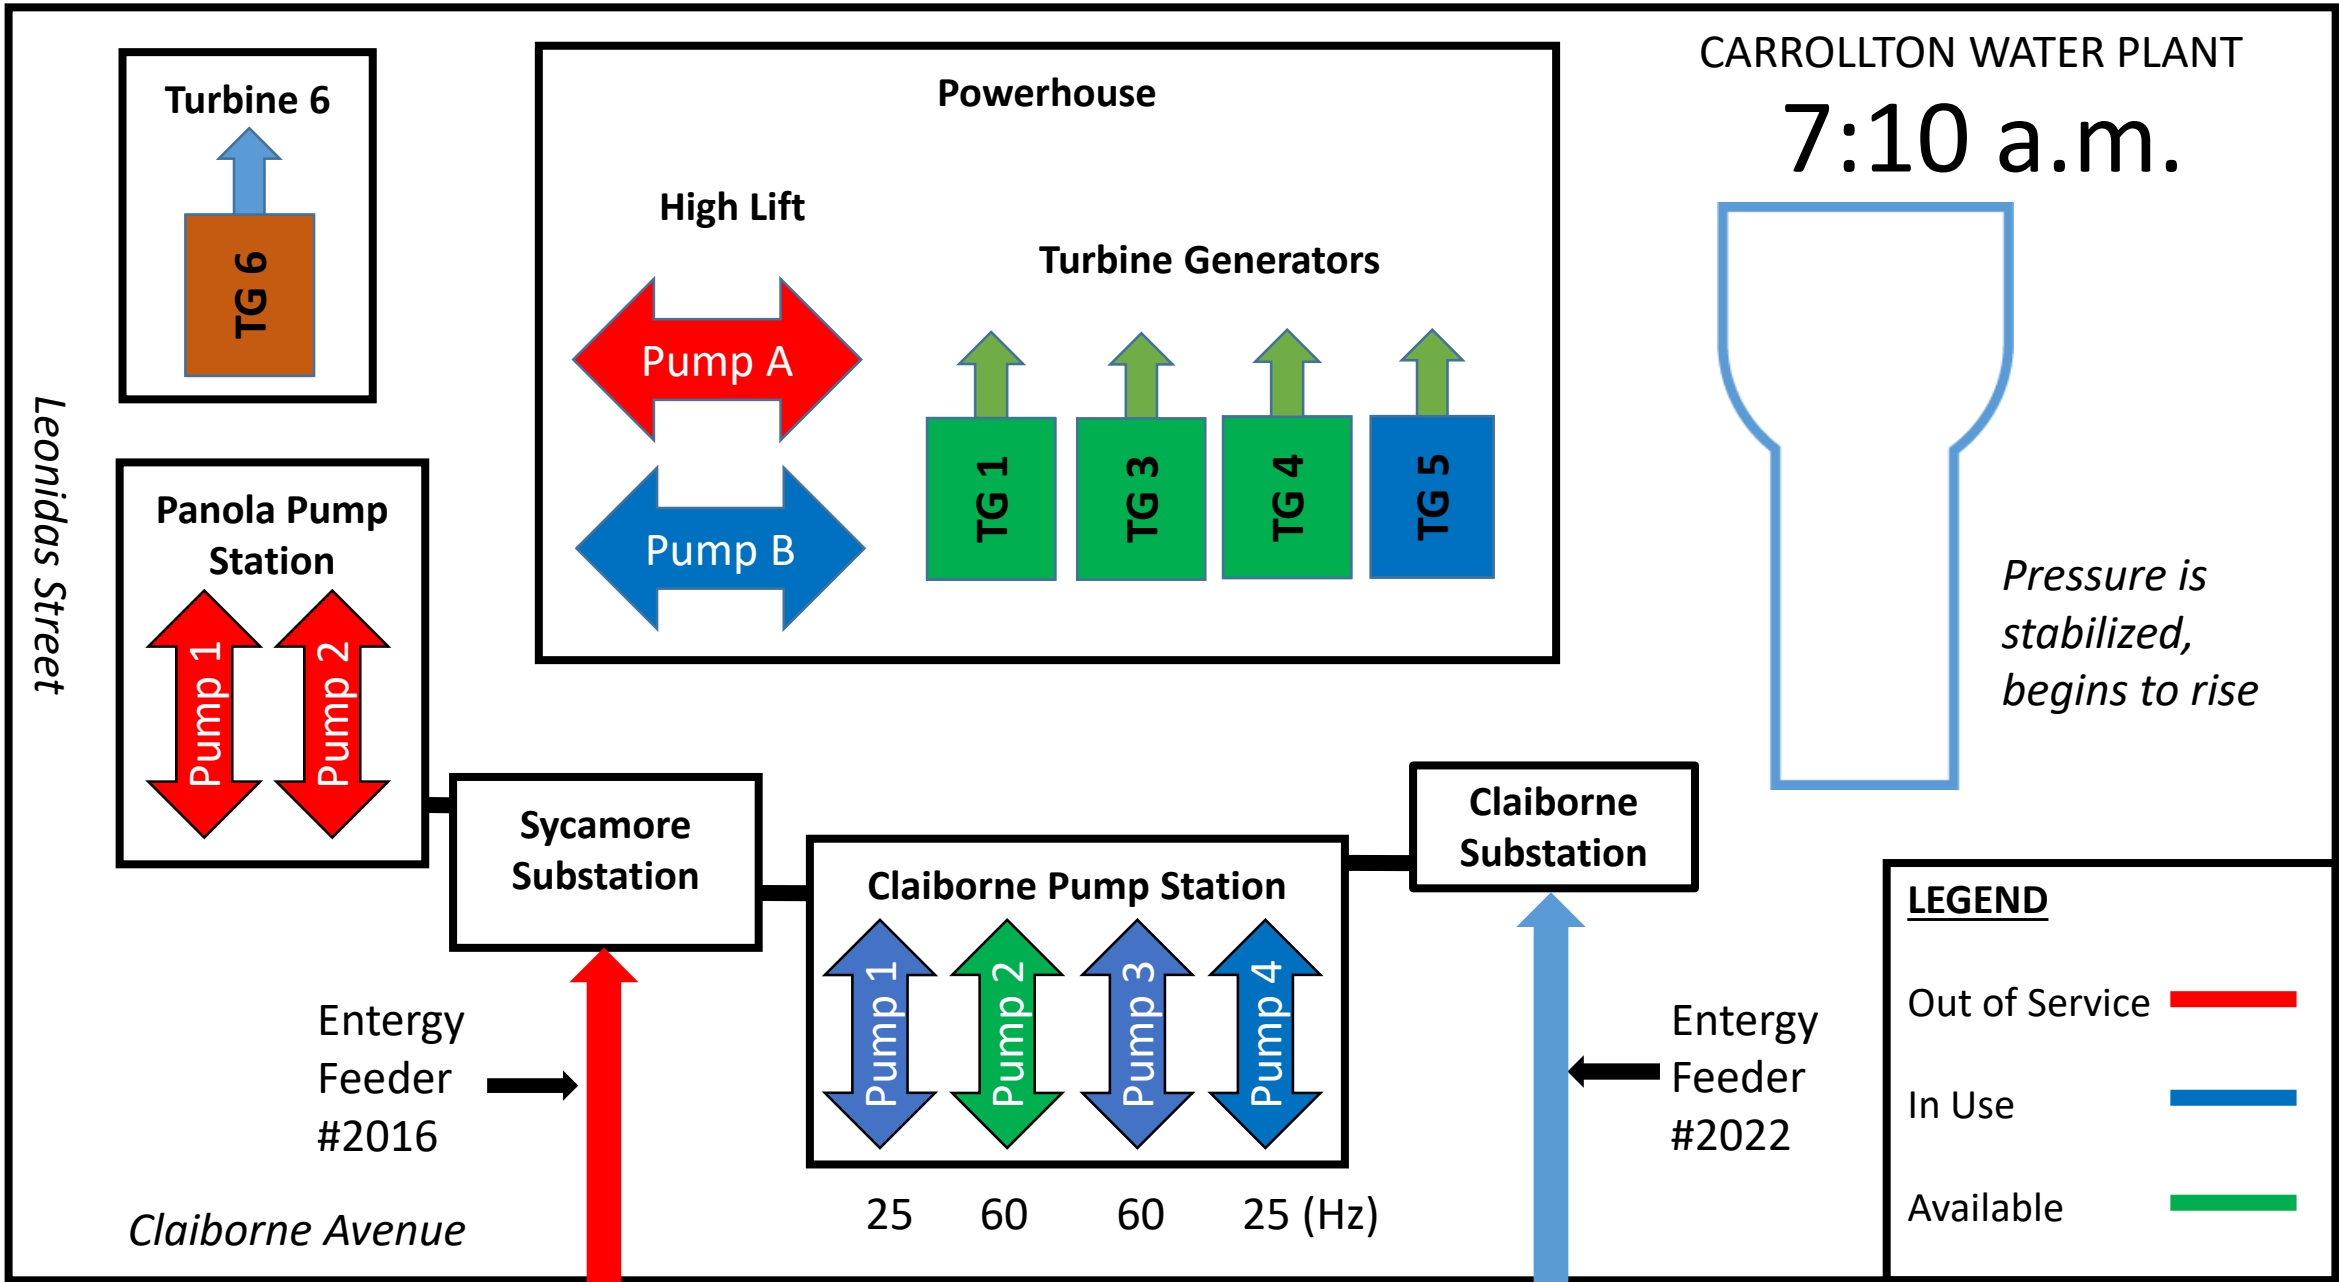
CARROLLTON WATER PLANT
7:10 a.m.

Pressure is stabilized, begins to rise
